ATLAS Muon Note
January 25, 2002

X-ray Tomograph results from two BIS Module 0 Chambers and improvements of the construction procedure on the basis of the results

D. Sampsonidis and Ch. Petridou
Aristotle University of Thessaloniki
Thessaloniki 54 006, Grrece

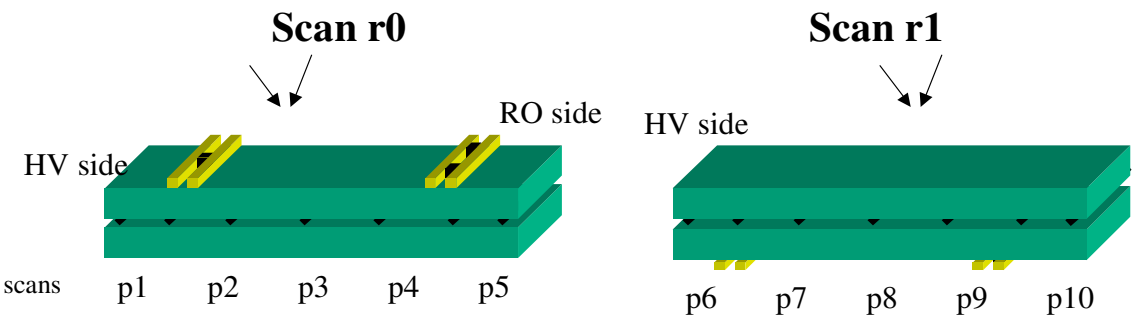
Several scans have been made across the tube layers at the X-ray tomograph. During the scans the chamber was supported (or suspended) on the three kinematical points using an appropriate frame. Figure 1 shows the scans performed with the BIS chamber in the two orientations. Five scans were made across the tubes numbered from p1 to p5 with the support points on top (scans r0) and five scans numbered from p6 to p10 with the support points at the bottom (scans r1) chamber rotated by 180° around the chamber x-axis (tube direction).

Figure 1: The various scans of the BIS chambers at two orientations.

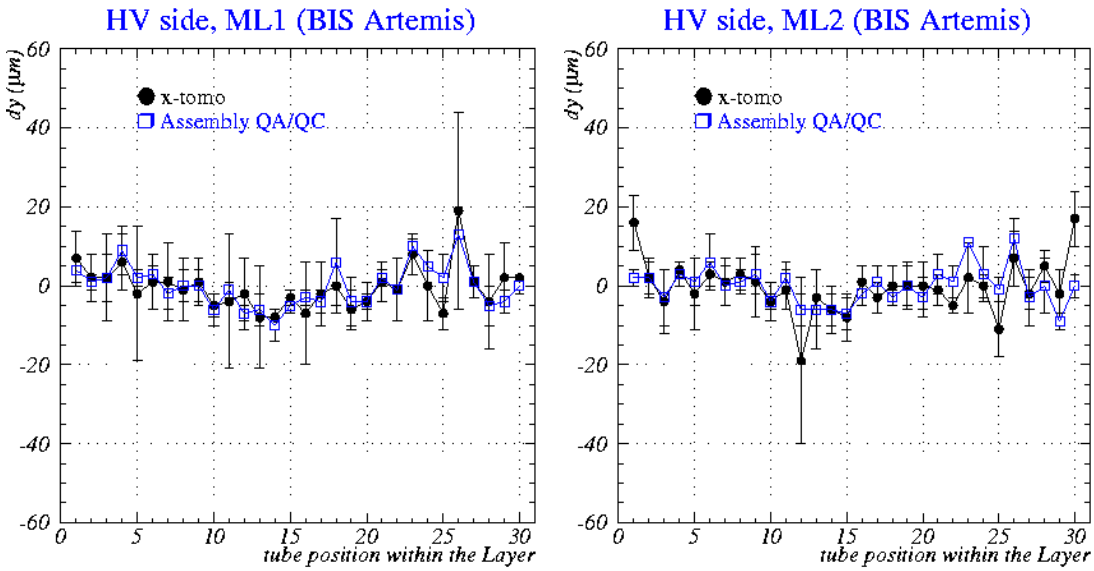
Figure 2 shows the y residuals of the tube position fitted by a straight line for the BIS chamber Artemis at the HV side for the thirty tubes of each Layer. The data were averaged for the tubes of each Multilayer (ML1, fig 2 left and ML2, fig 2 right). The circle points correspond to the x-tomo measurements and the square points correspond to the endplug height measurements during the chamber assembly. The error is the standard deviation of the four measurements which correspond to the four layers of tubes.

From figure 2 it is evident that the wire positions seen by the x-tomo follow the same pattern as the tube height measurements which essentially comes from the jig shape. This can be explained from the fact that the wire location with respect to the center of the endplug varies in a range of 10 microns rms and is uncorrelated in z an y direction

Figure 2: Average wire position in y for the ML1 (left) and ML2 (right) of BIS Artemis at HV side as measured by the X-ray tomograph (black circles). The open squares represent the average y tube position on jigs as measured during the chamber assembly QA/QC.

[2]. So, in the data averaged over the four tube layers contributes only in the error. The dominant factor for the resulted shape of the layer profile is the jig profile where the endplugs sit.

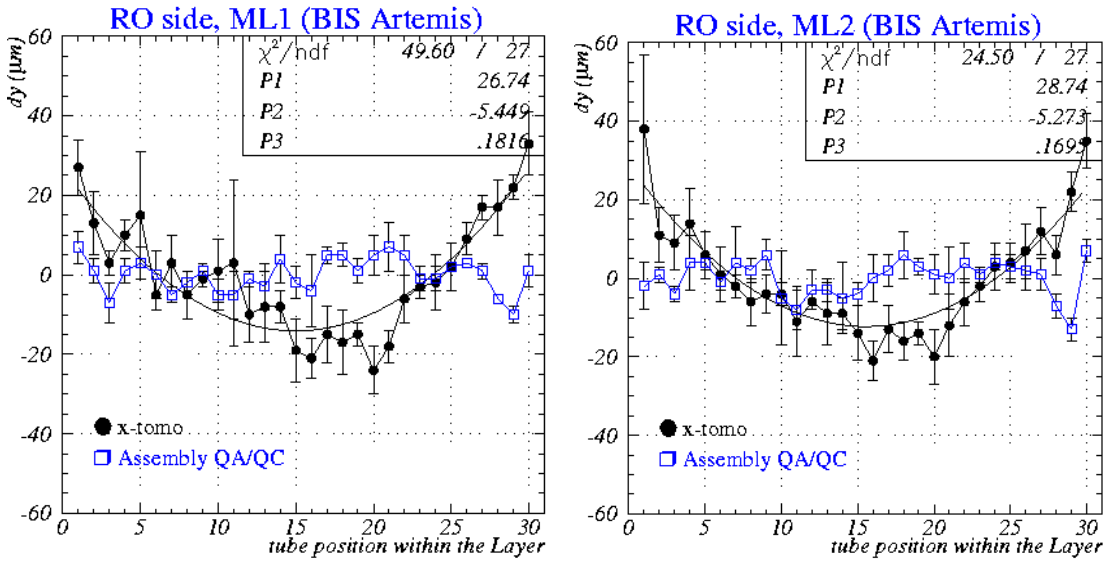
Figure 3: Average wire position in y for the ML1 and ML2 of BIS Artemis at RO side as measured by the X-ray tomograph (black circles). The open squares represent the average y tube position on jigs as measured during the chamber assembly QA/QC.

In figure 3 the results for the RO side are shown for the chamber suspended (r0 scans). The sag observed in the x-tomograph data is permanent as it was verified by the scans with the chamber supported (scans r1). This sag is originated by the gluing procedure followed for the support beams during the assembly of Artemis. The two support beams were glued together with the two U-pieces using a template. The most crucial point of the support beam assembly, which is shown in figure 4, is the planarity of the horizontal surfaces of the two U-pieces. These surfaces are the contact points of the chamber to the stiffback. If the two U pieces are not on the same horizontal plane,

stress may develop from the fixing of the stiffback to the chamber while gluing the support beam assembly to the first tube layer. The stress is released after removing the stiffback from the chamber, thus resulting in a permanent deformation of the chamber as the one observed.

In order to avoid problems described in section 2 resulting to permanent chamber deformations without cost increase for the U-pieces fabrication controlled thickness and planarity to a few microns an alternative scheme was followed to glue the support beams on the chamber. The support beams are placed via two templates on the first tube layer. The U-pieces are first connected to the stiffback and then glued to the support beams (figure 4, right). The gluing of the U-pieces to the support beams and of the support beams to the first tube layer is done simultaneously once their position is verified by lowering the stiffback. That way the gluing of the support beam structure to the chamber is done free of stresses. Two Rasnik systems are used to monitor possible deformation of the support beams. The Rasniks are glued on the support beams before they are placed on the first tube layer while they are on the granite table controlled thickness and planarity to a few microns.

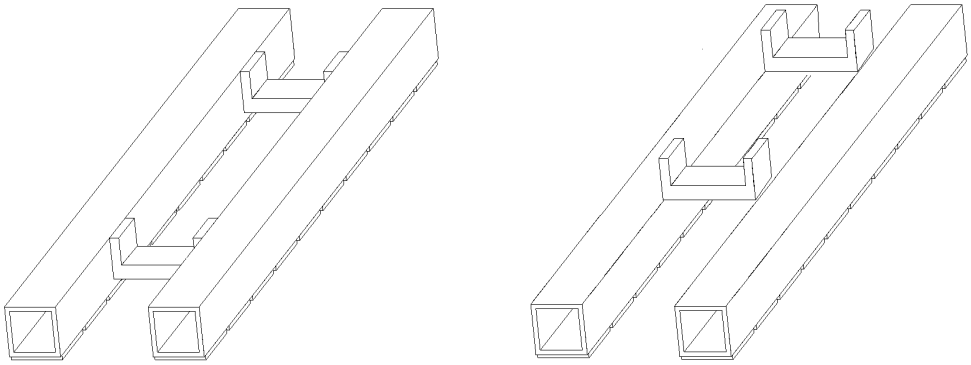
Figure 4: Assembly of the support beams with the U-pieces followed for the BIS chamber Artemis (left) and for the BIS Beatrice (right).

This method was followed in the second prototype. Data from the x-tomograph analysis of the second chamber Beatrice show that there is no deformation across the

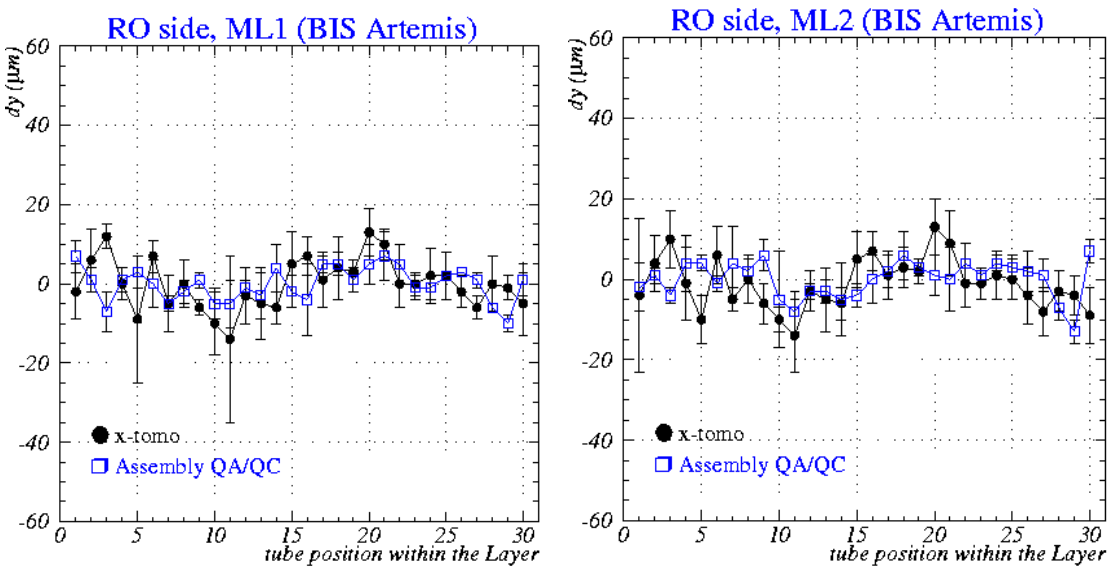
Figure 5: Average wire position in y for the ML1 and ML2 of BIS Artemis at RO side as measured by the X-tomograph (black circles), after the correction applied in order to exclude the permanent sag across the layers. The open squares represent the average y tube position on jigs as measured during the chamber assembly QA/QC

Removing this permanent deformation of the RO side by fitting the chamber sag with a second order polynomial and subtracting from the data, the x-tomo data follow the jig pattern as at HV side (Figure 5)

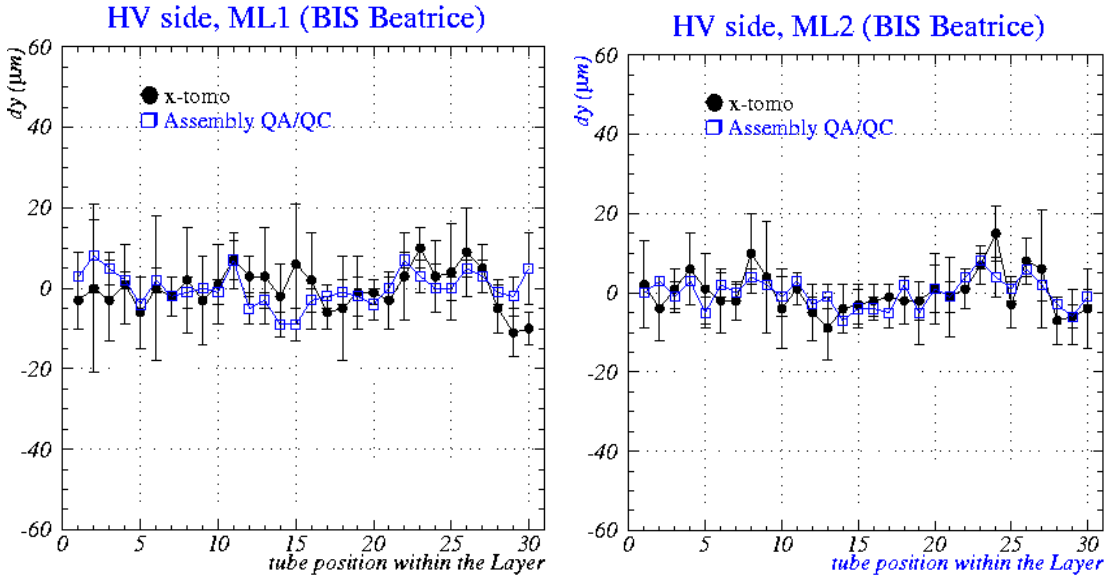
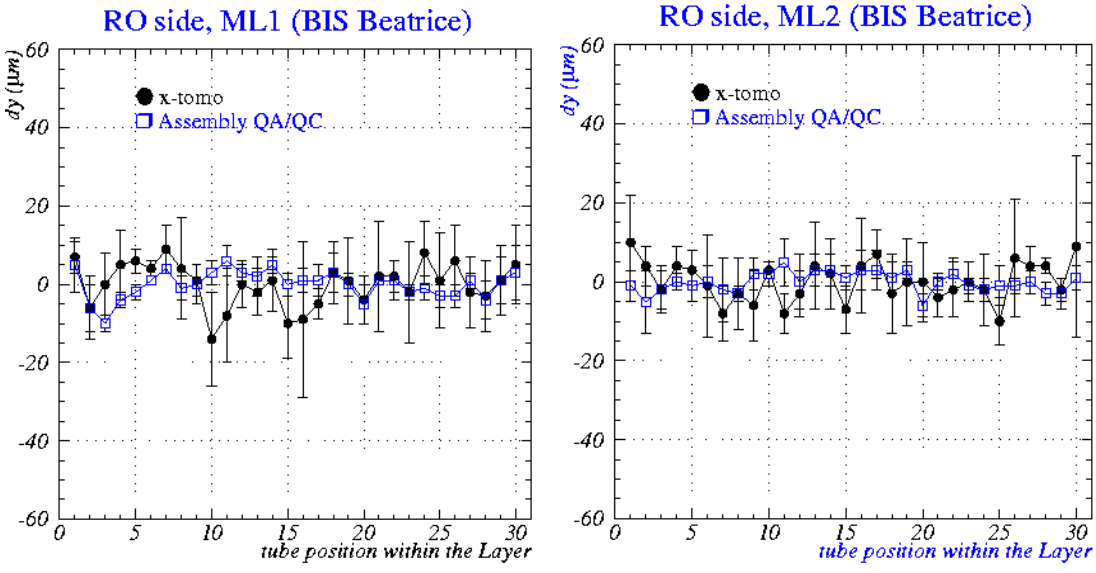
tubes. Figure 6 and 7 show the average y residuals of the wire positions for Multilayers 1 and 2 at HV and RO sides for the BIS chamber Beatrice. The x-tomograph data show a pattern similar to what was observed in chamber Artemis following the same originated from the jigs.

Figure 6: Average wire position in y for the ML1 and ML2 of BIS Beatrice at HV side as measured by the X-tomograph (black circles). The open squares represent the average y tube position on jigs as measured during the chamber assembly QA/QC.

Figure 7: Average wire position in y for the ML1 and ML2 of BIS Beatrice at RO side as measured by the X-tomograph (black circles). The open squares represent the average y tube position on jigs as measured during the chamber assembly QA/QC.

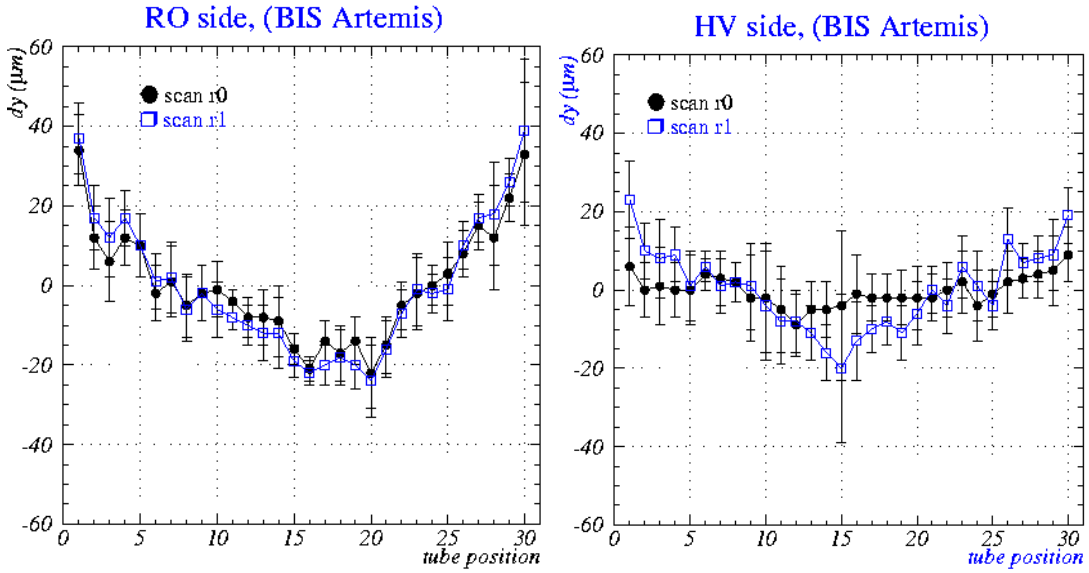
The BIS chamber Artemis was scanned in two orientations with a help of a frame. In the first case the chamber was suspended by the kinematical points and in the second one it was supported having the mounting blocks bellow the tubes (see figure 1). Figure 8 shows the chamber profile (y-residuals averaged for the eight layers) at RO and HV sides, for the two orientations (r0 and r1). Figure 9 shows the difference of the averaged y value of tubes in the two orientations r0 and r1, as a function of tube position within the layer for the HV and RO side respectively.

Figure 8 Average wire position in y for the RO and HV side of BIS Artemis as measured by the X-tomograph in the two orientations r0 (circles) and r1 (squares).

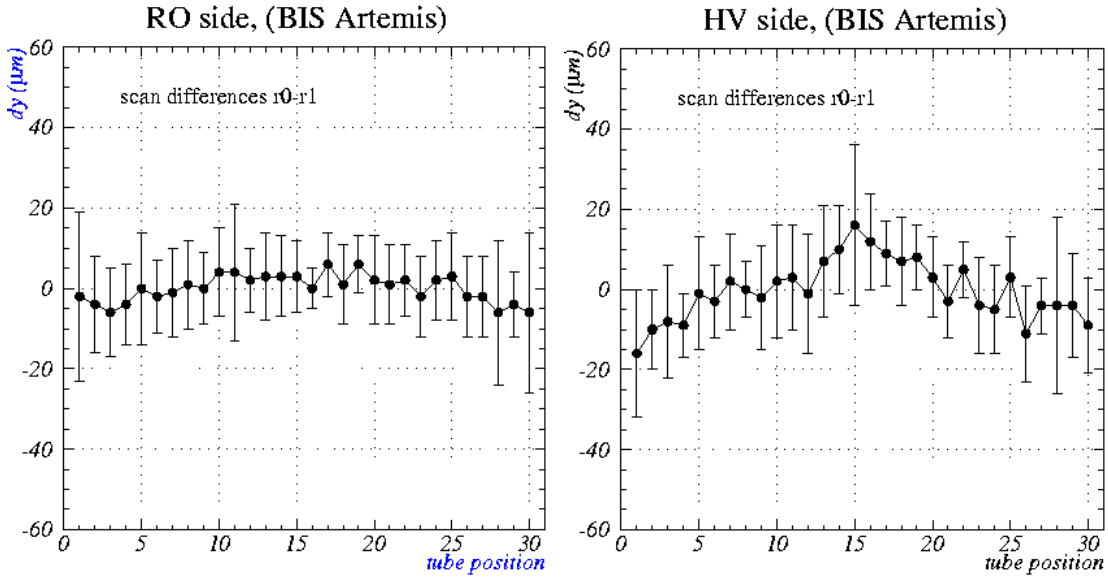
The difference between the two scans (r0-r1) on the RO side is less than ±10 μm. On the HV side the difference is also small, bellow 20 μm with the largest values at the two ends of the multilayers. This is related to the fact that there is a single point support on the HV side.

Figure 9: Difference of the two scans r0-r1of the average wire position in y for the RO and HV sides of the BIS Artemis.

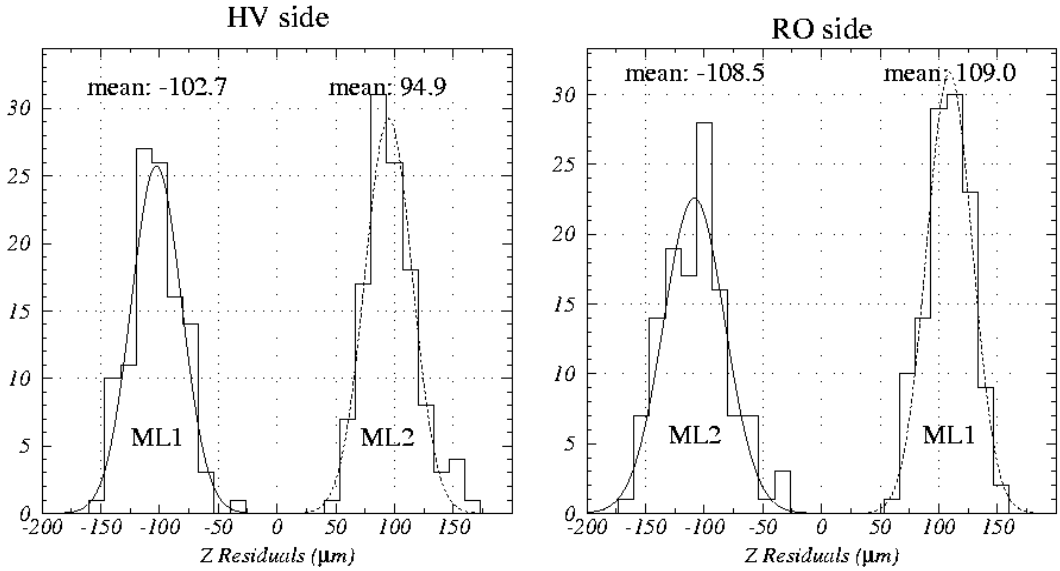
The fitting of the data for BIS Artemis with the grid parameters fixed to the nominal values showed a horizontal shift of the top multilayer w.r.t the bottom one on the HV side of about 208 μm. On the RO side the relative shift of the two multilayers is in the opposite direction of 225 μm. This corresponds to relative rotation of the top multilayer with respect to the bottom multilayer. This effect is due to an accident happened during the chamber assembly as described in [3]. The shift and rotation are originated from the replacement of two broken base blocks during the assembly and has been measured by the Rasnik system during construction.

Figure 10: Distribution of the residuals in Z of the wire positions measured by the X-tomograph using a common grid fit with the five parameters fixed to the nominal values (BIS Artemis).

Figure 10 shows the distribution of the residuals in Z of the wire positions measured by the X-tomograph with respect to the grid fit with the parameters fixed to the nominal values for the BIS Artemis for HV and RO sides. The two peaks correspond to the two multilayers and the distance between the peaks corresponds to the relative shift of the two multilayers. Figure 11 shows the distribution of the residuals of the wire positions in Y direction.

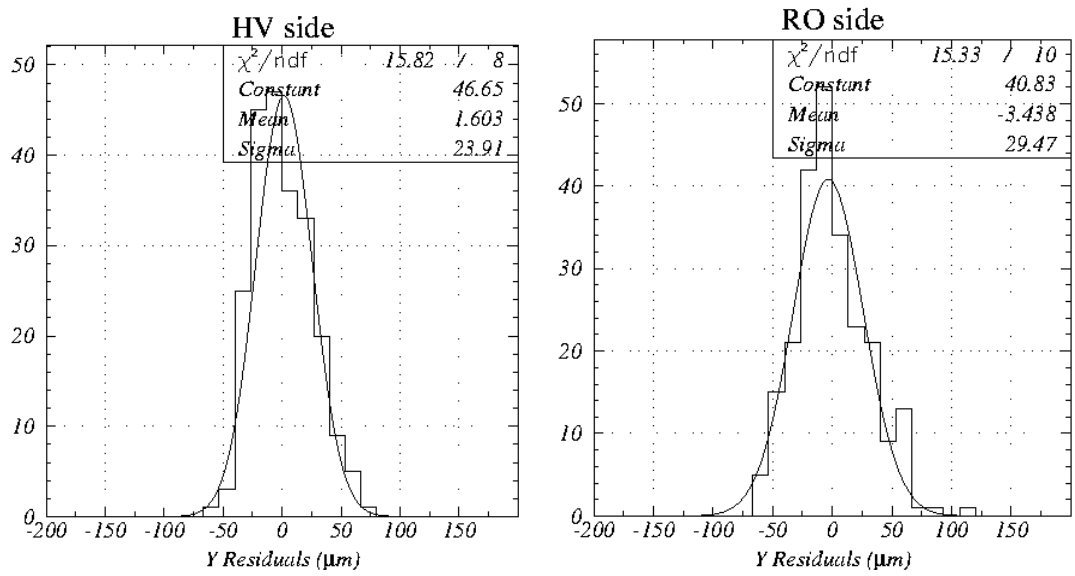
Figure 11: Distribution of the residuals in Y of the wire positions measured by the X-tomograph using a grid fit with the parameters fixed to the nominal values. (BIS Artemis)

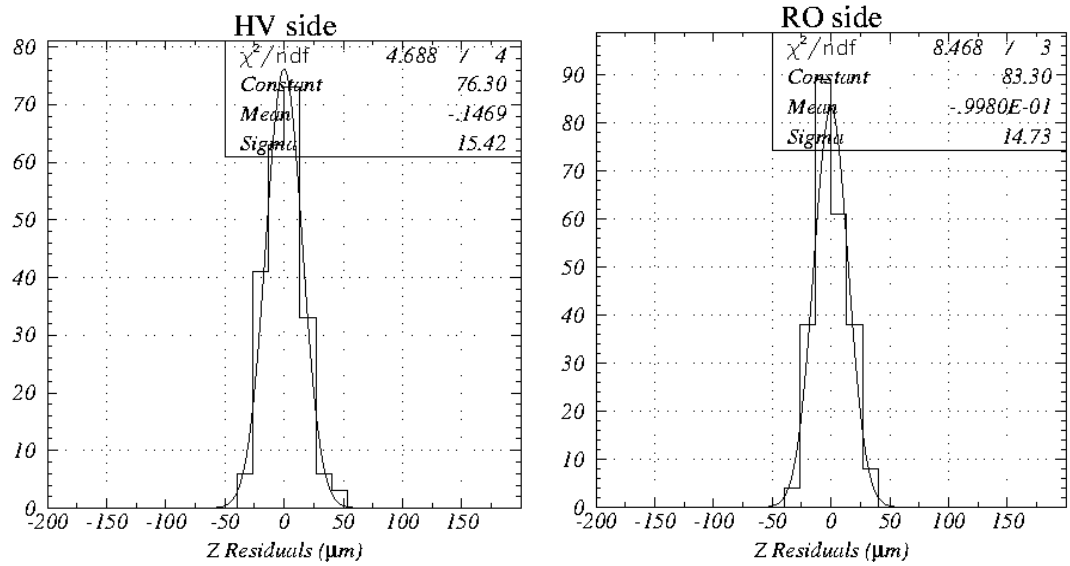
The data were also fitted with five parameters grid leaving the parameters free. The results of the grid parameters are shown in Table II. Figures 12 and 13 show the distribution of the residuals of the wire positions in Z and Y respectively, measured by the X-tomograph with respect to the grid fit with the parameters free.

Figure 12: Distribution of the residuals in Z of the wire positions measured by the X-tomograph with respect to the grid fit with the parameters free (BIS Artemis).

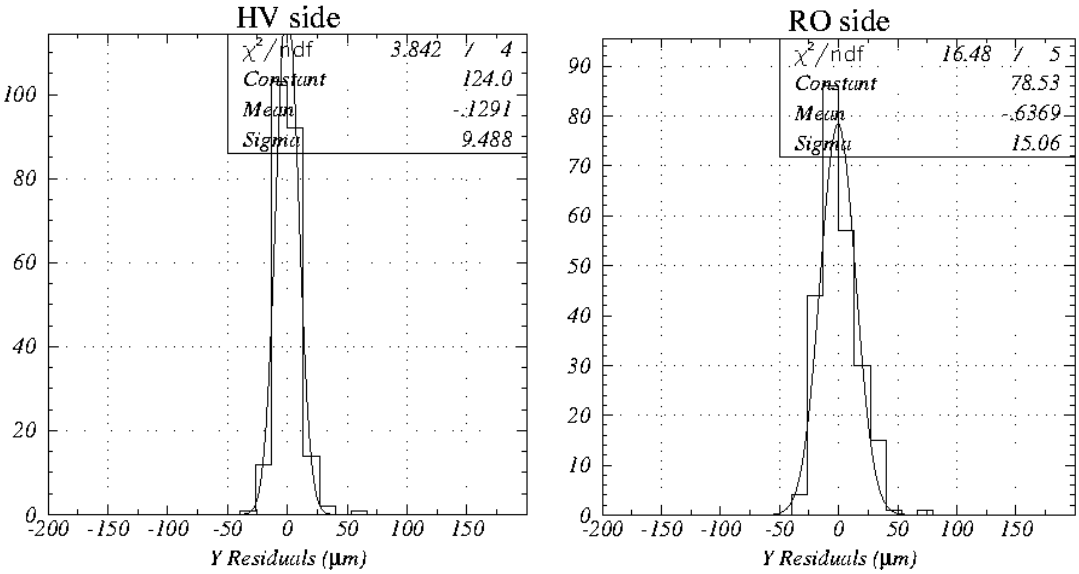
Figure 13: Distribution of the residuals in Y of the wire positions measured by the X-tomograph with respect to the grid fit with the parameters free (BIS Artemis).

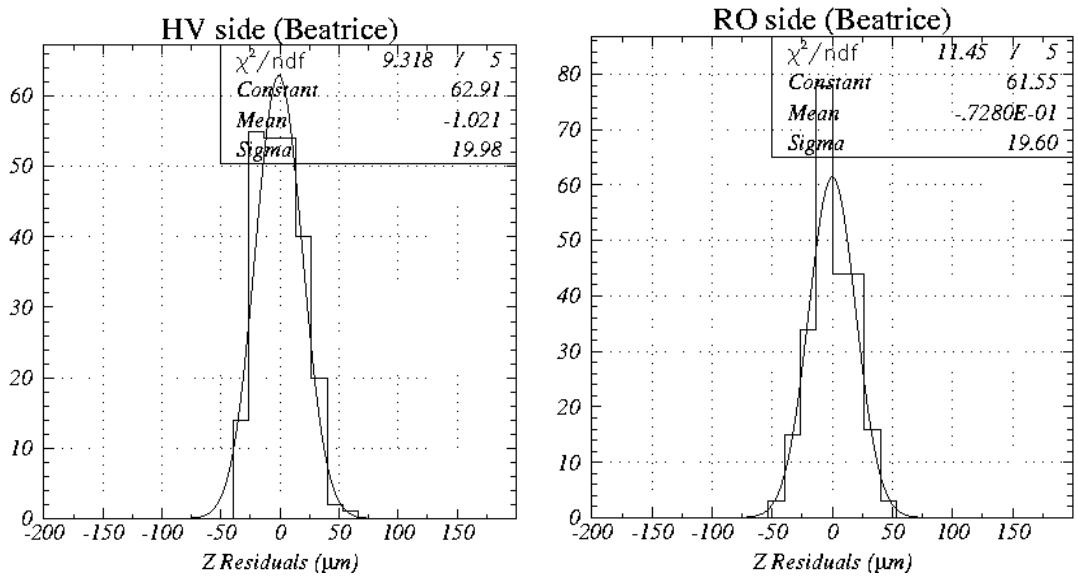
Figure 14: Distribution of the residuals in Z of the wire positions measured by the X-tomograph with respect to the grid fit with the parameters fixed to the nominal values. (BIS Beatrice)

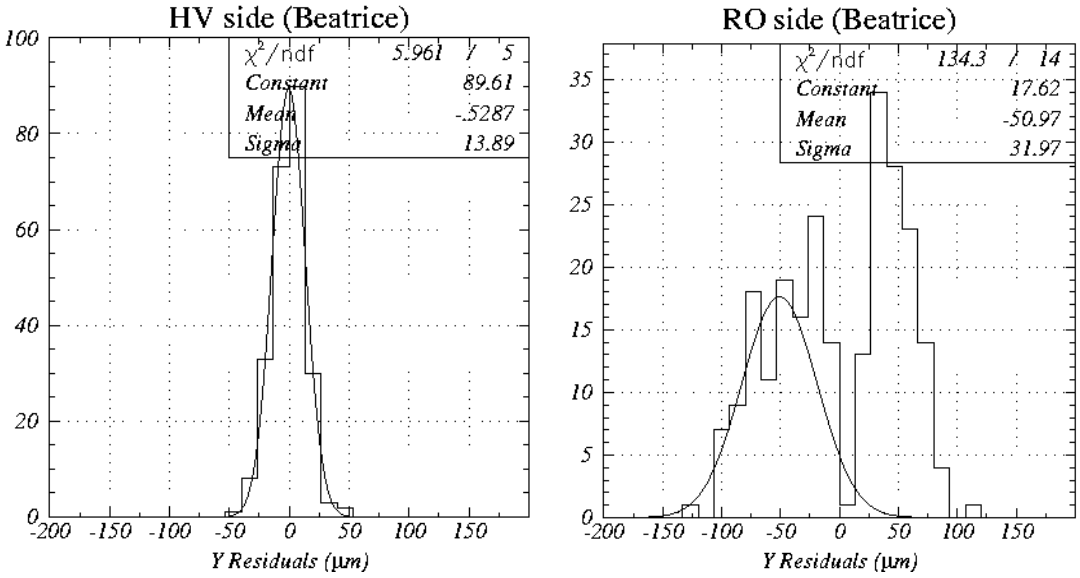
Figure 15: Distribution of the residuals in Y of the wire positions measured by the X-tomograph with respect to the grid fit with the parameters fixed to the nominal values. (BIS Beatrice)

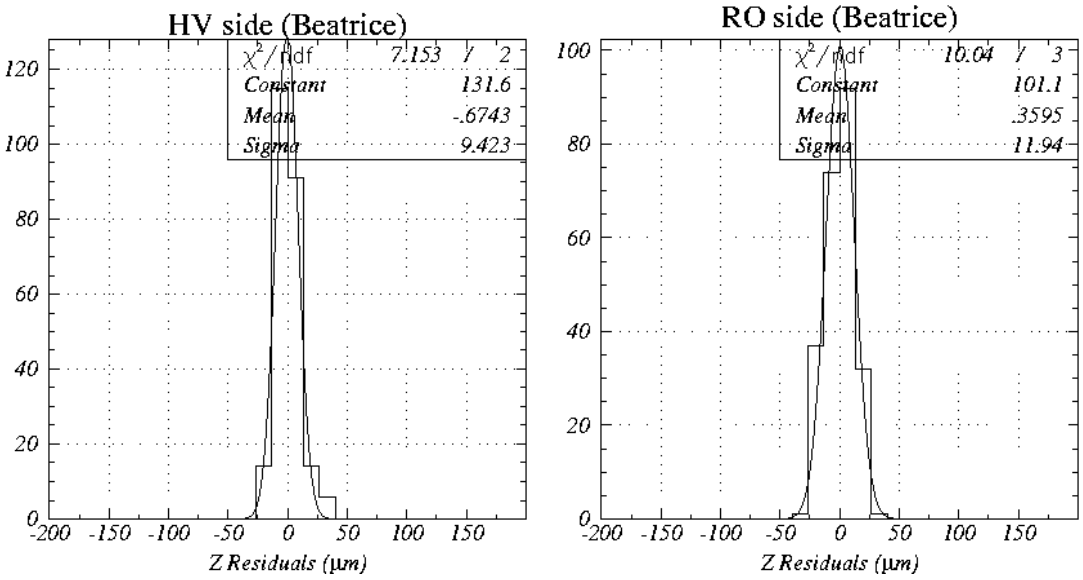
Figure 16: Distribution of the residuals in Z of the wire positions measured by the X-tomograph with respect to the grid fit with the parameters free (BIS Beatrice).

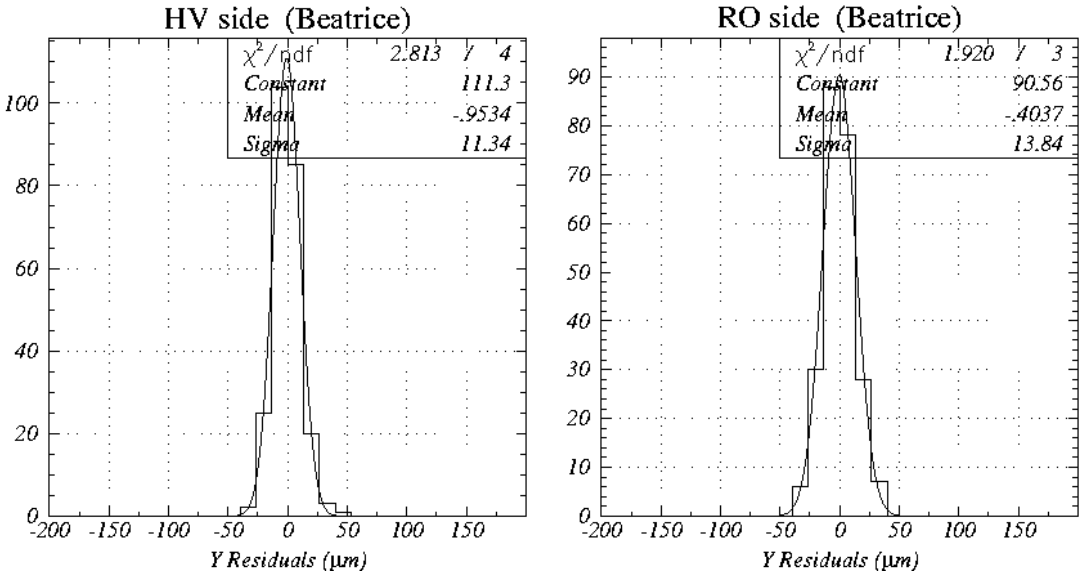
Figure 17: Distribution of the residuals in Y of the wire positions measured by the X-tomograph with respect to the grid fit with the parameters free (BIS Artemis).
